SAMPLE INSPECTION REPORT

346 Nowhere Drive, Birmingham, AL 35007

Inspection Date:
2/14/2014

Prepared By:
Goodsell Home Inspections, LLC
Alabaster, AL 35007
(205) 369-9856
gcci10@aol.com

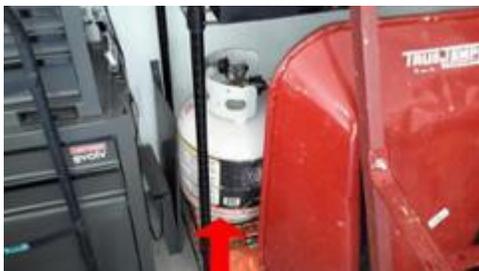
Propane Gas Should Not Be Stored Indoors

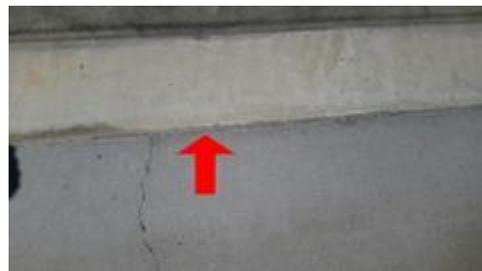
Repair: Slab edges are exposed which create tripping hazards. These need to be backfilled to where they are flush with finished grade to eliminate these hazards.
Repair: Cut the shrubs back to protect the house.

Tripping Hazard At Garage Door Threshold

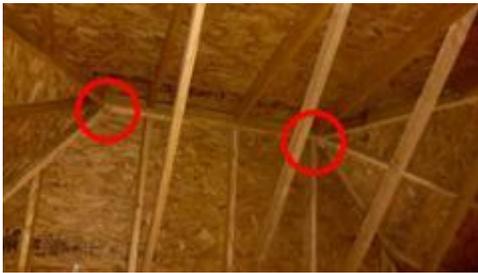
Monitor: The ridges of the roof appear to lack proper bracing. This applies to the main ridge and the gable ridges.

Ridge Braces Missing

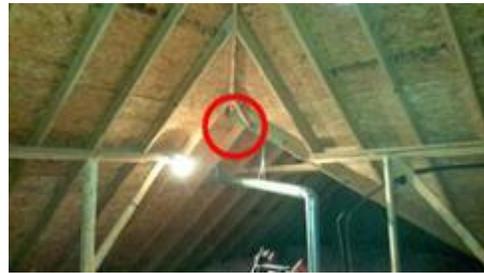
Gable Ridge Braces Missing - Example

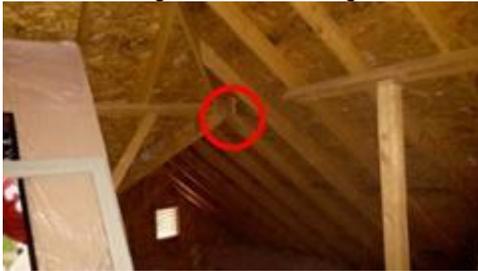
Gable Ridge Braces Missing - Example

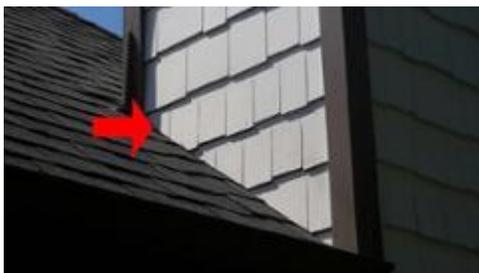
Remove abandoned TV dish bracket and caulk bolt holes.
Repair: The clearance at the siding at the roof is insufficient. This condition leaves the siding vulnerable to rot. This detail is usually repaired when siding needs repair or replacement or when re-roofing work is performed.
Repair: The siding base flashing is rusting. It should be prepped, primed and painted to extend its useful life span.
Repair: The flashing is loose and should be caulked between the brick and the metal flashing to avoid leaks. It is not recommended that the flashing be caulked between the siding and the metal. This would negate the purpose of the flashing altogether.
Portions of the roof were viewed from the ground. Some sections of the roof could not be viewed.

Siding Clearance Is Lacking

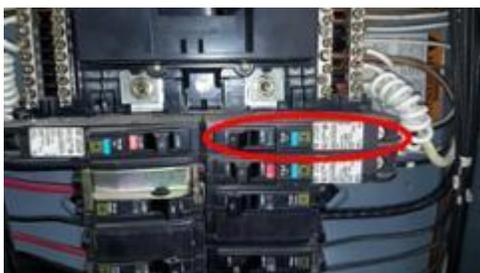
There is a defective arc fault breaker in the panel. It does not test correctly. See Photo For Location

Arc Fault Breaker Inoperative

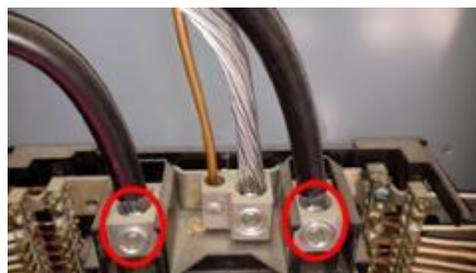
Repair: Poor electrical connections within the main distribution panel should be improved. The aluminum wire connections should be coated with a dielectric grease to avoid corrosion and fire hazards.

Dielectric Grease Missing

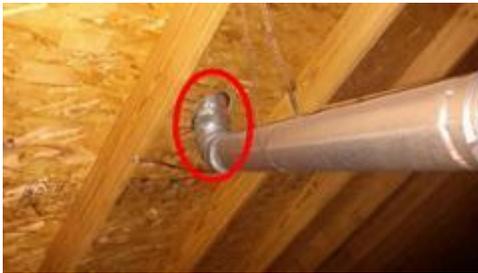
Repair, Safety Issue: There is insufficient clearance between the exhaust flues and combustible materials. This is a fire hazard. This condition should be corrected by a qualified heating technician all the way through the house.

Hot Flue Vent Pipe Clearance Lacking
Fire Hazard

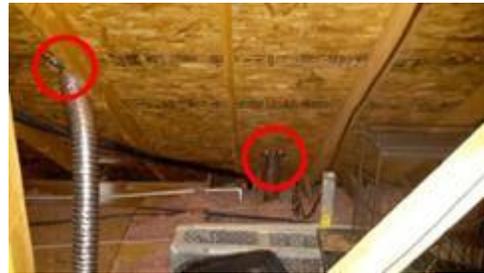
Holes/Light Visible at some of the vent pipes. These could be sources of leaks.

Light Coming In At Vent Pipes Possible Leak Sources

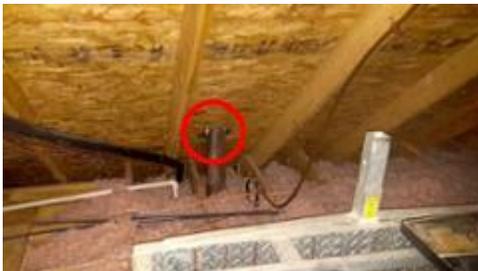
Hot Flue Vent Pipe Clearance Lacking From
Combustibles - Fire Hazard

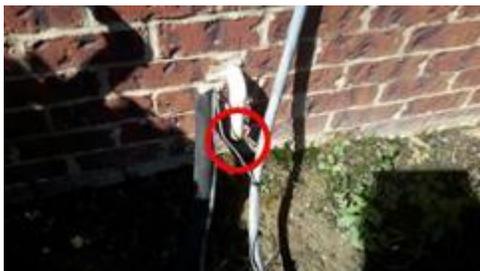
Repair: The discharge location of the condensate line for the air conditioning system should be improved. It needs to be extended away from the house to avoid attracting termites to the home.

Condensate Discharge Location Poor

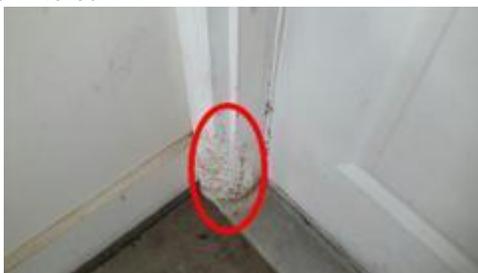
Dog Damage At Garage Door

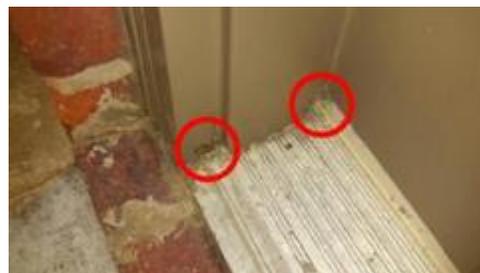
Minor Wood Decay At Door Jamb Noted

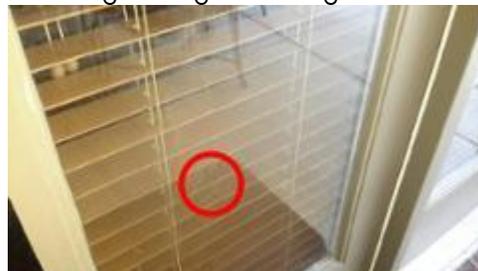
Dog Damage To Glass

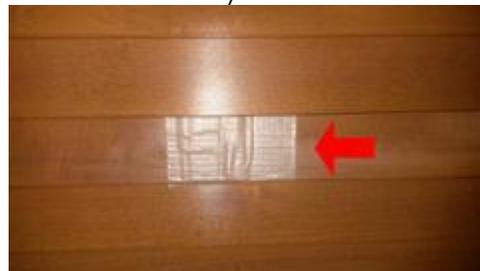
One Blind Was Noted As Damaged

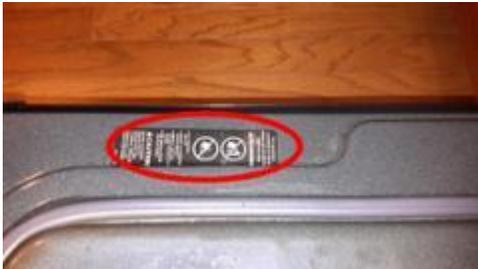
Improve: An anti-tipping device is needed at the range.
Safety Hazard

Anti - Tipping Device Missing At Range
Life Safety Hazard

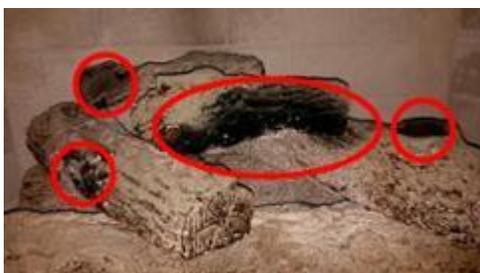
Improve: Seal around the gas line at the fireplace fire box wall penetration.
Gas logs appear to be generating soot.

Gas Logs Generating Soot
